PROTOTYPE TESTS OF THE HOLLOW-JET VALVE STILLING
BASIN, AUXILLIARY JET FLOW GATE, AND GENERAL IN-
SPECTION OF THE HYDRAULIC STRUCTURES AT TRINITY DAM,
TRINITY RIVER DIVISION--CENTRAL VALLEY PROJECT,
CALIFORNIA

July 26, 1963

Travel Report #2636

Subject: Prototype tests of the hollow-jet valve stilling basin, auxiliary jet flow gate, and general inspection of the hydraulic structures at Trinity Dam, Trinity River Division--Central Valley Project, California

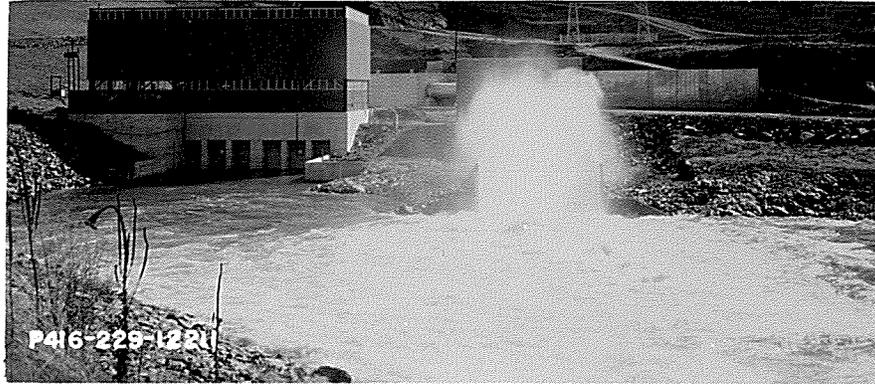
The jets from the valves did not penetrate the stilling basin pool. There was considerable mist and spray from the jets which combined with the spray from the surface turbulence in the stilling basin and obscured the vision of the stilling action in the pool. When observed from the far bank, Figure 1, the impact of the jets appeared to create waves about 8 feet high in the basin that leveled out to about 5-foot high surges at the end of the basin. The waves were about 6 inches high along the left bank, 1.5 to 2.5 feet high on the bank opposite the stilling basin, and 0.2 foot high in the afterbay. The water surface along the wing-walls at the end of the basin surged from elevation 1898.3 to elevation 1900.2. The tailwater elevation at the powerplant after-bay was 1899.9.

10% Valve opening, Discharge = 1130 cfs, T. W. Elevation = 1899.90

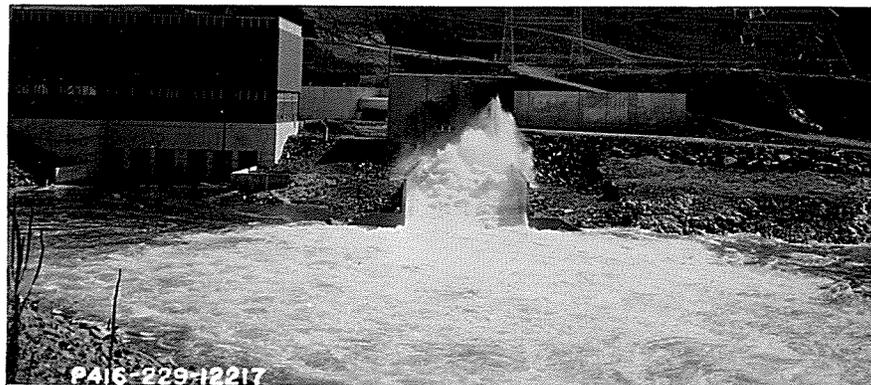
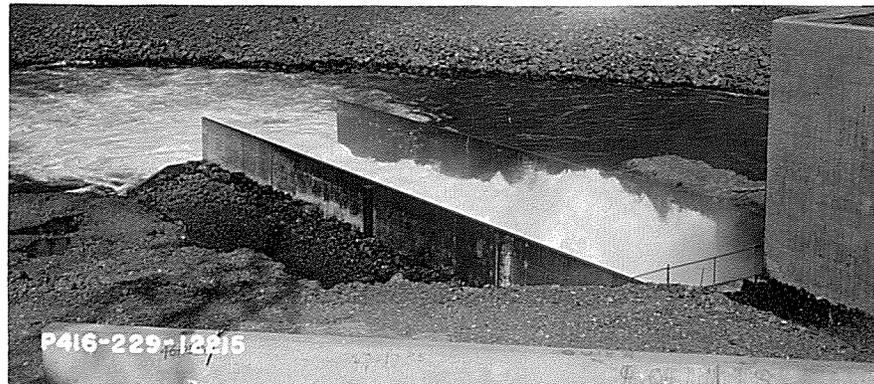
The stilling action at this gate opening was very effective, Figure 1. The high point of the boil was usually about 90 feet downstream from the valves but occasionally moved upstream about 40 feet. The top of the boil was about 4 feet below the top of the side walls but occasional high surges carried 15 to 20 feet above the walls.

The high surges usually were moving in an upstream direction and impinged on the jet causing a high splash that landed on the front of the control house. Small stones were sometimes seen in the high splashes. Several of these stones have been found in the control house and were reported to be less than 1 inch in diameter. The roughness and turbulence of this jump were confined to the upstream portion of the basin and flow in the downstream 40 feet was comparatively smooth with about a 4-foot surge in the water level.

25% Valve opening, Discharge = 2760 cfs, T. W. Elevation = 1901.05

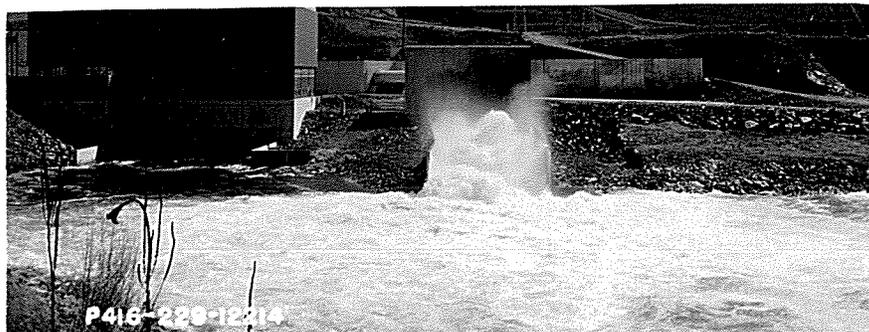
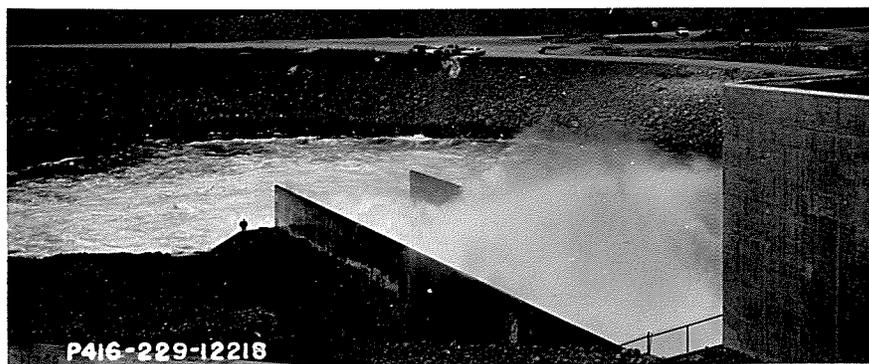
The jump was very turbulent, in the basin for this operating condition, Figure 2. The toe of the jump (not visible in previous operation) was about 50 feet downstream from the valves, exposing about half of the center dividing wall. The high point of the boil varied from 110 feet to 150 feet downstream from the valves. The high point of the boil varied from 4 to 12 feet below the top of the side walls with an occasional spurt rising about 15 feet above the walls. There was no back splash against the control house but considerable splash passed over the sides of the basin walls. At the end of the basin the water level between the walls varied from 4 to 8 feet higher than the outside tailwater.

50% Valve opening, Discharge = 5260 cfs, T. W. Elevation = 1902.30

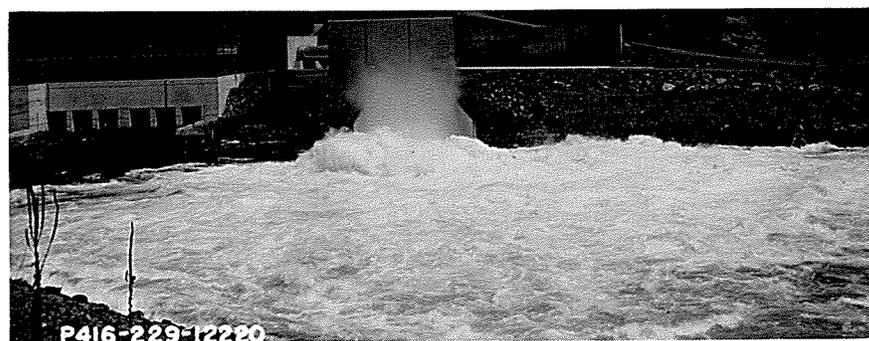
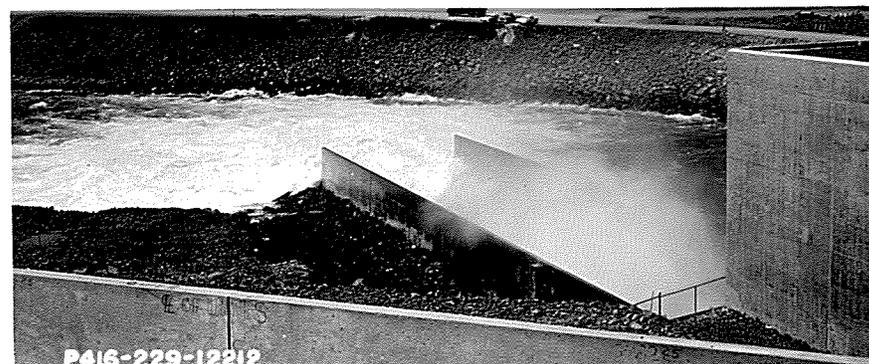
The hydraulic jump action for this condition was good, Figure 2, but the boil at the end of the jump extended beyond the end of the basin. The toe of the jump varied from 50 to 70 feet downstream of the valves, exposing the full length of the dividing wall at times. The high point of the boil was about 20 feet beyond the end of the basin; making the length of the jump, from the toe to the boil, about 170 feet long. The high point of the boil was usually 4 feet below the top of the sidewalls, but surged about 4 feet above and below this. An occasional splash or spurt in the basin rises 20 to 30 feet in the air. An occasional rock, estimated to be 3 to 4 inches in diameter, was occasionally seen in the boil.

75% Valve opening, Discharge = 7190 cfs, T. W. Elevation = 1903.4

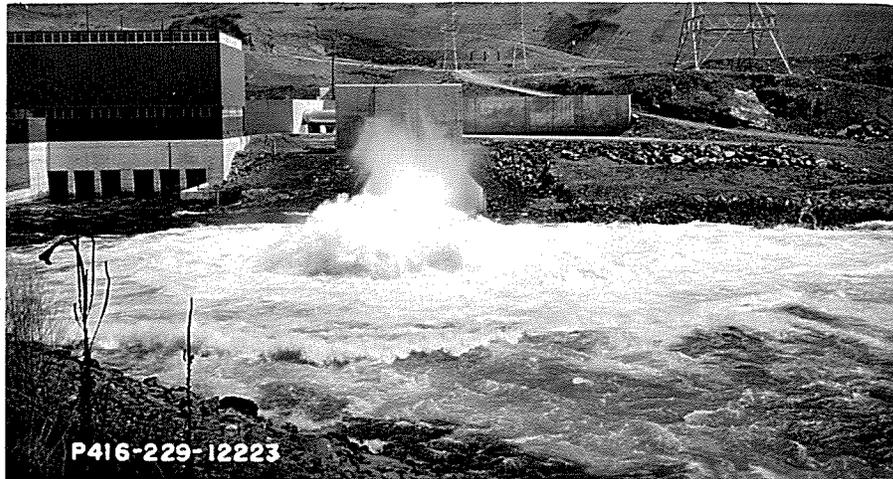
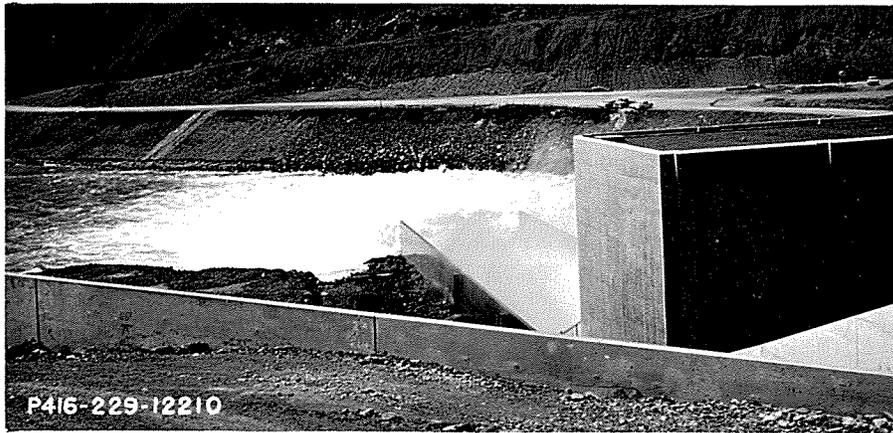
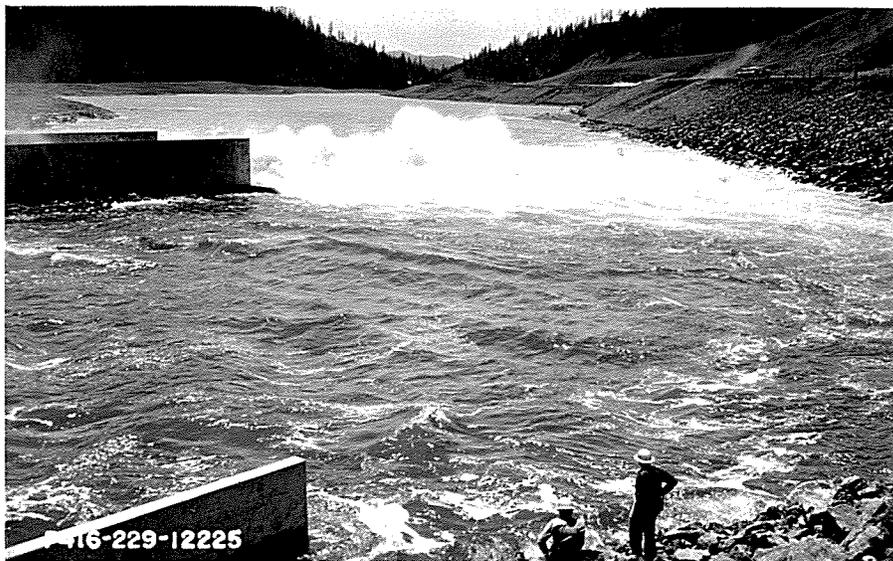
The toe of the jump remained fairly constant about 70 feet downstream from the valves, near the end of the center dividing wall. The boil at the end of the jump moved back and forth from the end of the basin to 40 to 60 feet downstream from the end; however, it was predominantly beyond the end of the basin, Figure 3. The top of the boil varied from the top of the side walls to about 6 feet below the top. A secondary boil or surge formed near the end of the basin. Although the formation of this boil was sporadic, it was higher than the downstream boil and usually overtopped the sidewalls. The stilling action was very rough and turbulent, but the turbulence did not extend upstream into the afterbay. The turbulence from the stilling action moved across the channel from the basin and turned downstream. Wave action on the left and opposite bank was estimated to be about the same as during the 75 percent operation. The tailwater elevation in the afterbay averaged about 1903.7; the wave action was in the form of slow surges about 1.2 feet in magnitude.

100% Valve opening, Discharge = 8620 cfs, Tailwater
Elevation = 1903.7

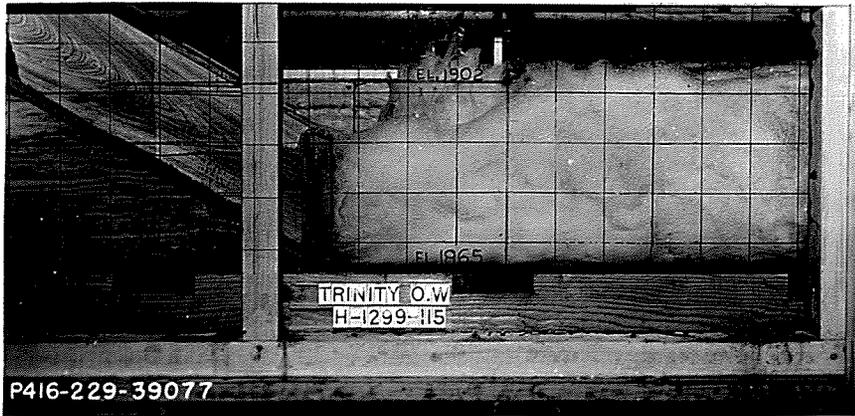
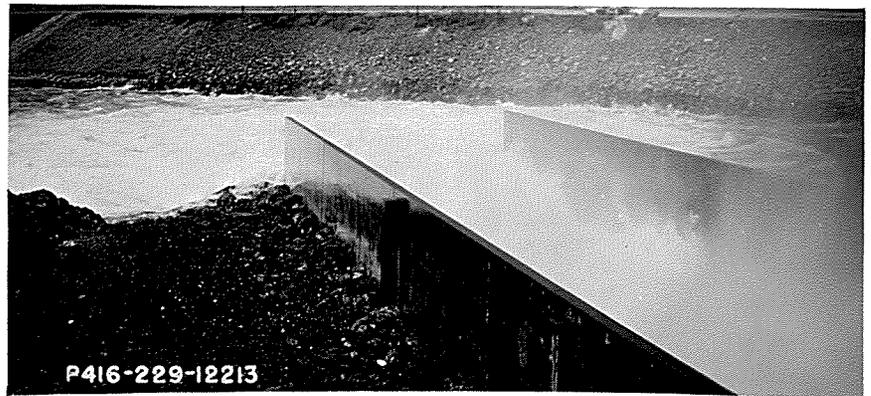
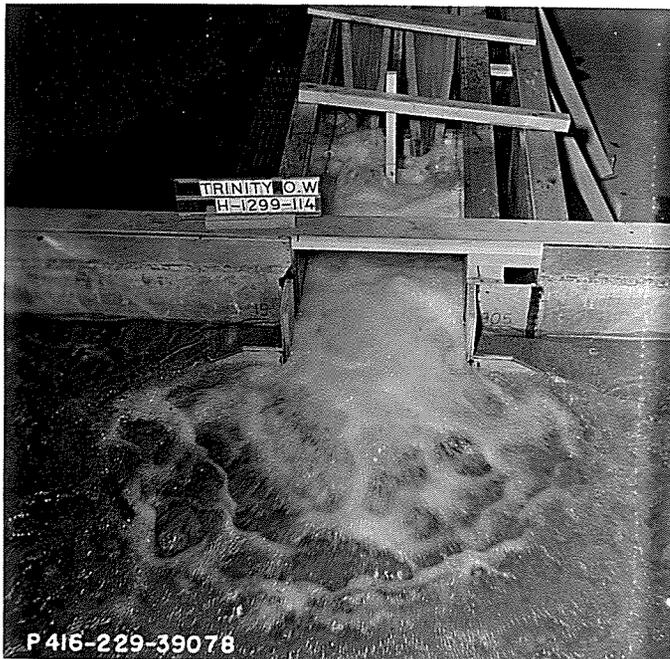
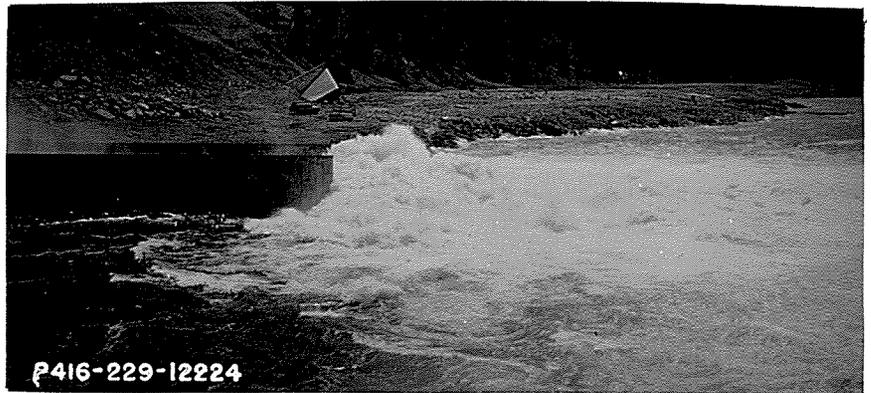
TRINITY DAM OUTLET WORKS
Hollow Jet Valve Stilling Basin
Model-Prototype Comparison

The comparable prototype operation was 7,200 cfs at 375 feet of head with the tailwater at elevation 1903.4, Figure 4. The toe of the jump was the same as indicated in the model. However, the boil was about 20 feet beyond the end of the basin, 50 feet farther downstream than in the model, and the top of the boil was usually about 4 feet below the top of the sidewalls. The difference in the location and height of the boil can be attributed to the higher head on the valves creating a higher flow velocity, resulting in a longer hydraulic jump. The larger amount of air entrainment in the prototype hydraulic jump also had some effect on the difference in the appearance of the boil. The waves in the downstream channel were 3.0 to 3.5 feet high, 2.0 feet higher than measured during the model studies. The higher waves were due to part of the hydraulic jump action occurring beyond the confines of the stilling basin.

The prototype operation for 75 percent valve opening discharged a flow quantity similar to that used for maximum model discharges, although at a higher head. For this operation the model prototype conformity was very good, Figure 4.

Discharge = 7190 cfs, Head = 375', Tailwater Elevation = 1903.4

Discharge = 7670 cfs, Head = 315', Tailwater Elevation = 1903

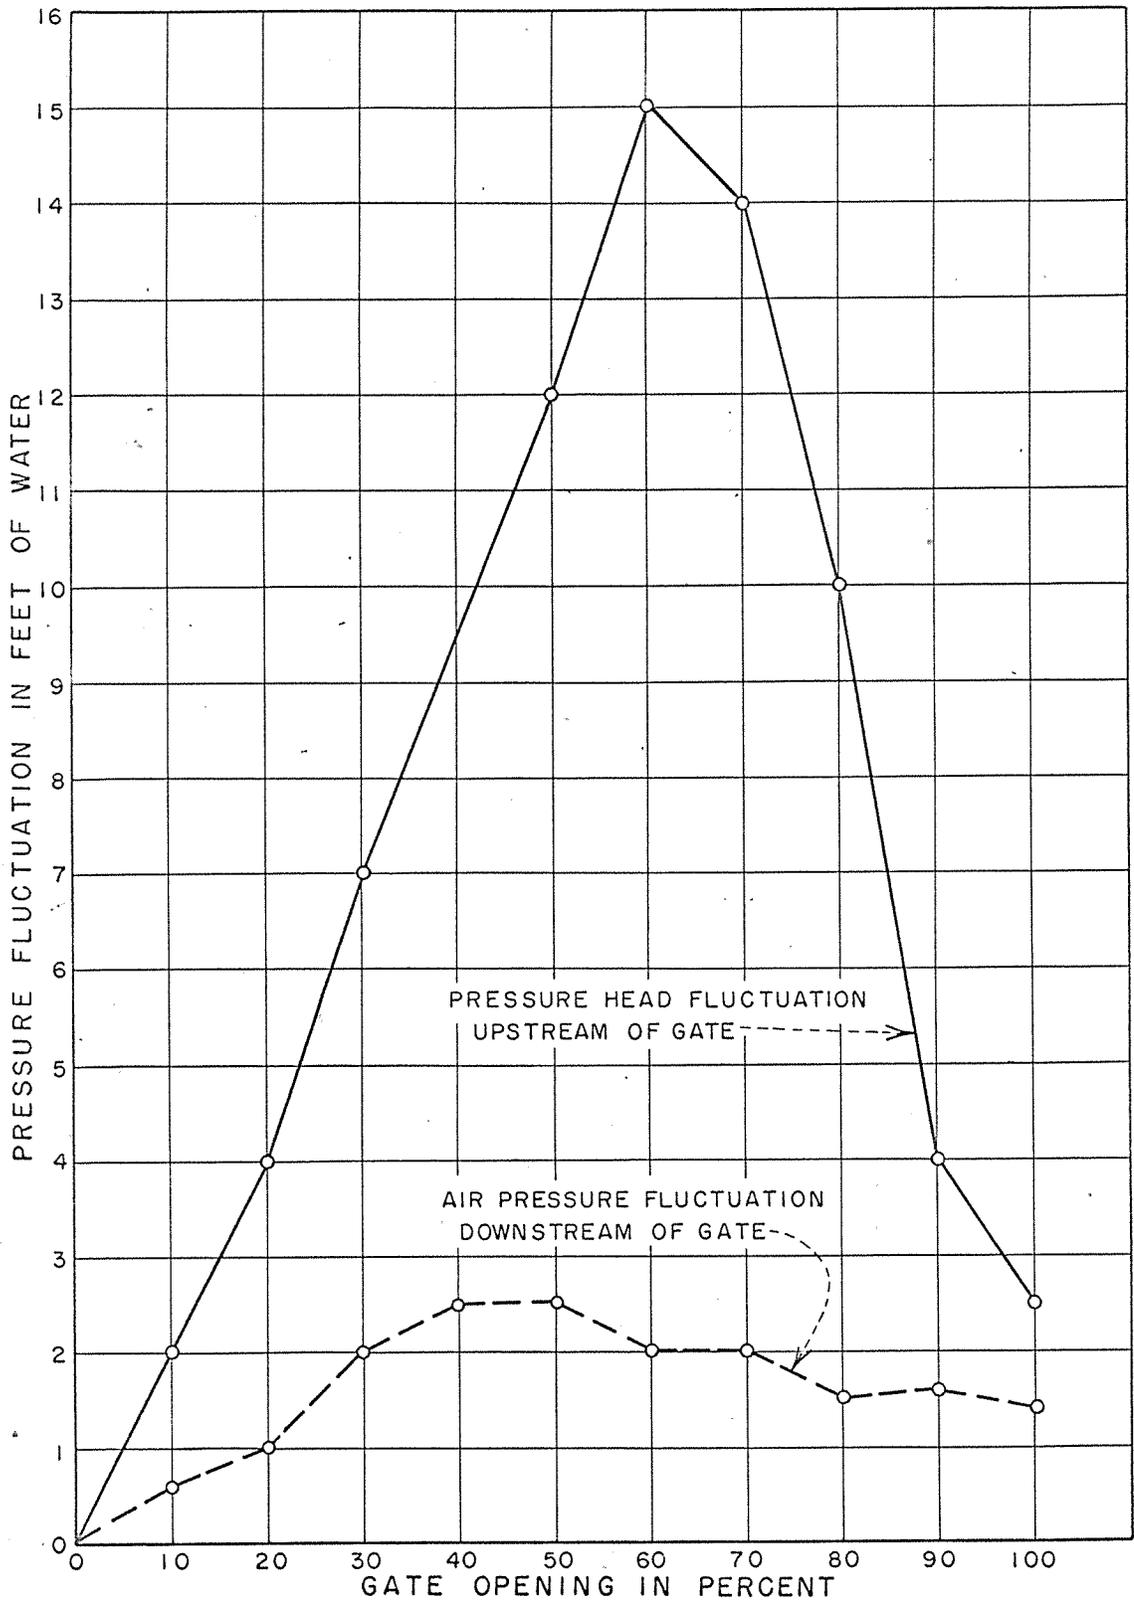
The jet flow gate was opened in 10 percent increments from fully closed to fully open. The pressure fluctuations were recorded during a 2- to 3-minute period. The pressure head fluctuation varied from about 2 feet at the 10 percent and 100 percent openings to 15 feet at the 60 percent opening, Figure 5. The air pressure fluctuations varied from about 0.6 foot at 10 percent opening to a maximum of about 2.5 feet at 40 to 50 percent opening. There was no obvious relationship between the air pressure and pressure head fluctuations except that they both showed the greatest fluctuation in approximately the same range of gate openings.

TRINITY DAM AUXILIARY OUTLET WORKS
 PRESSURE FLUCTUATION UPSTREAM
 AND DOWNSTREAM OF JET FLOW GATE

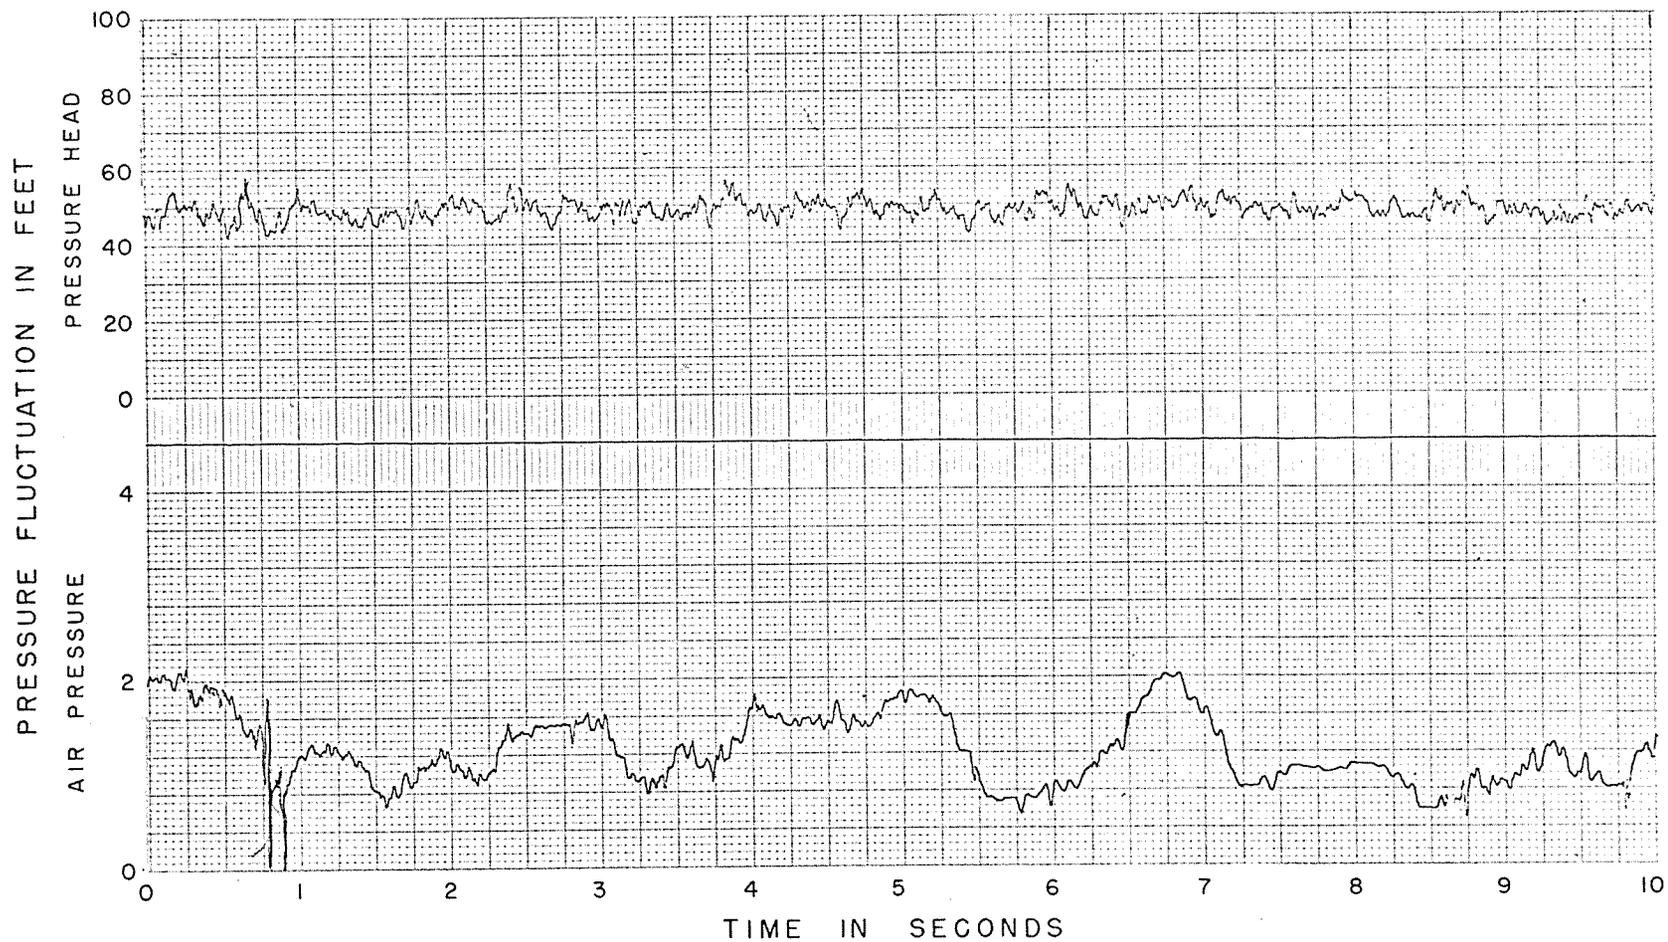
The air pressure fluctuations had a frequency of about 0.5 to 1.0 major cycles per second, with a secondary cycling of about 20 cycles per second. The minor cycles were less than 0.1 foot of water in magnitude. The pressure head fluctuations were consistent at about 20 to 25 cycles per second. A typical section of the recording is shown on Figure 6.

TRINITY DAM AUXILIARY OUTLET WORKS
 TYPICAL OSCILLOGRAPH RECORDS OF
 PRESSURE FLUCTUATIONS AT 60% GATE OPENING

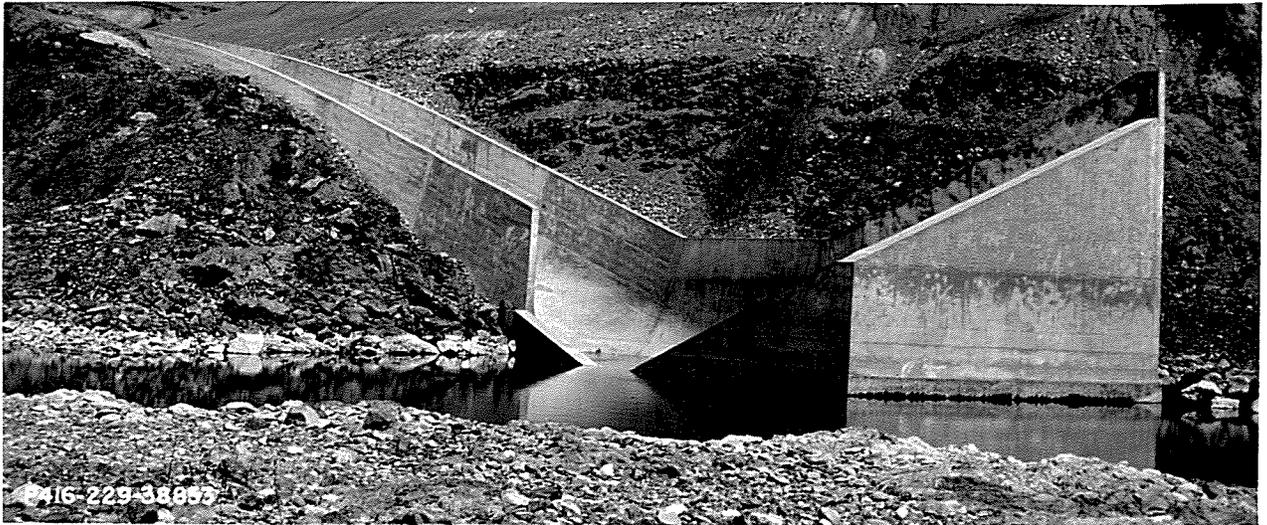
The area of river channel downstream from the flip bucket has been severely eroded by the impact of the jet. A hole was eroded along the right side and end of the bucket, Figure 7A. The hole was full of water and its depth could not be determined; however, it did not appear to have undermined the structure. There is an extensive eroded area about 250 feet downstream and to the right of the flip bucket; this hole is 40 feet wide and 70 feet long. From the ground surface to the water surface in the hole is about 12 feet; there was no means of determining how deep the hole extended below the water surface. An even larger eroded area is located about 150 feet directly downstream from the bucket, Figure 7B. This hole was about 50 feet long by 100 feet wide and seemed to be about the same depth as the other eroded area. The impact and flow from the jet has cleared all loose material from the ground in this area as

Erosion at side and end of Flip Bucket

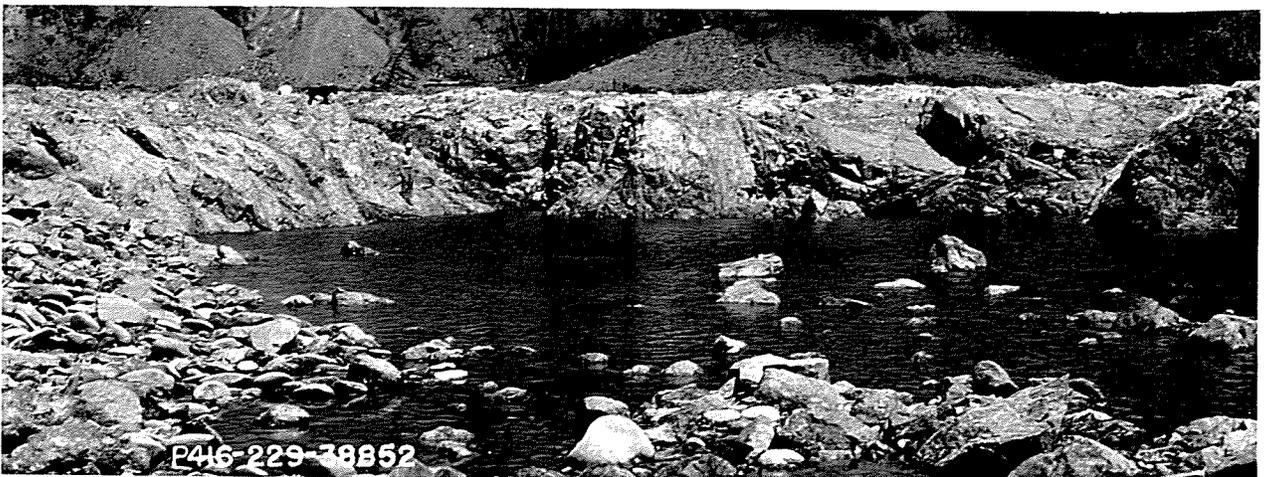
The jet impact area downstream from the flip bucket has been extensively eroded in two areas, Figure 7; one about 100 feet directly downstream,

the second about 200 feet downstream and to the right of the bucket. These areas are sufficiently removed from the structure that there is not danger of undermining.

The material from the eroded areas has formed a bar that partially constricts the improved river channel.

Eroded area downstream of Flip Bucket

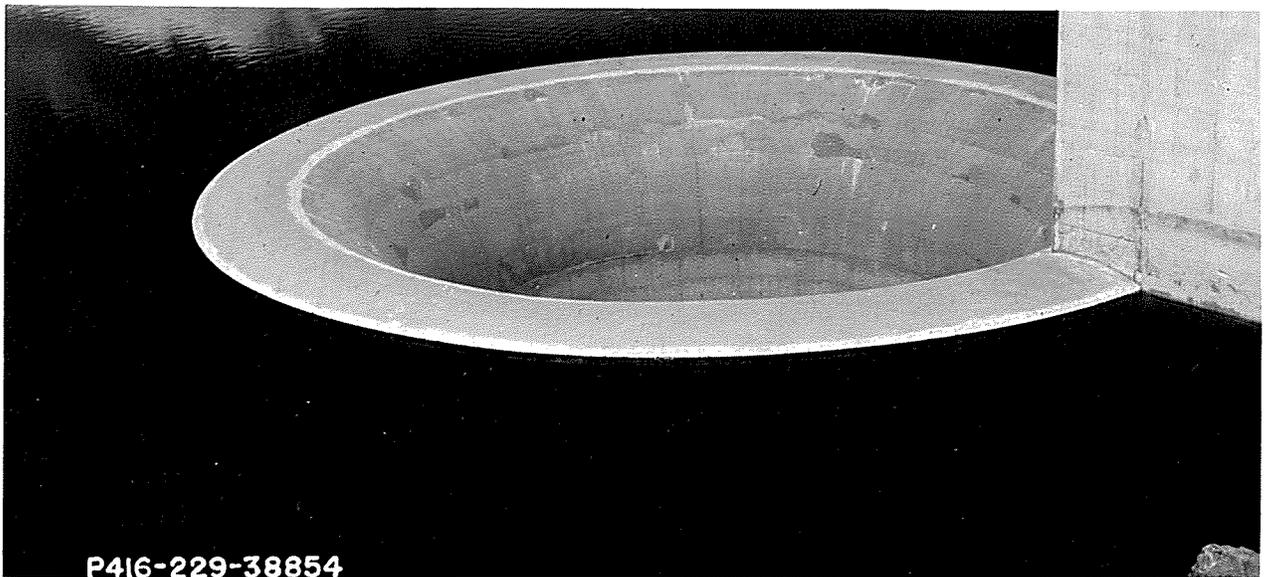
Morning Glory Spillway Crest.--Light colored streaks were noticed on the upstream and downstream side of the crest axis, Figure 7C. From the dam embankment these streaks appeared to be damaged concrete. However, close examination showed that some misalignments in the crest curve had been ground-off causing the lighter colored areas.

Morning Glory entrance and eroded areas downstream of Flip Bucket
